REFERENCENIST
PUBLICATIONS**NBSIR 85-3158**

Fire Performance of Interstitial Space Construction System

J. Randall Lawson

May 1985

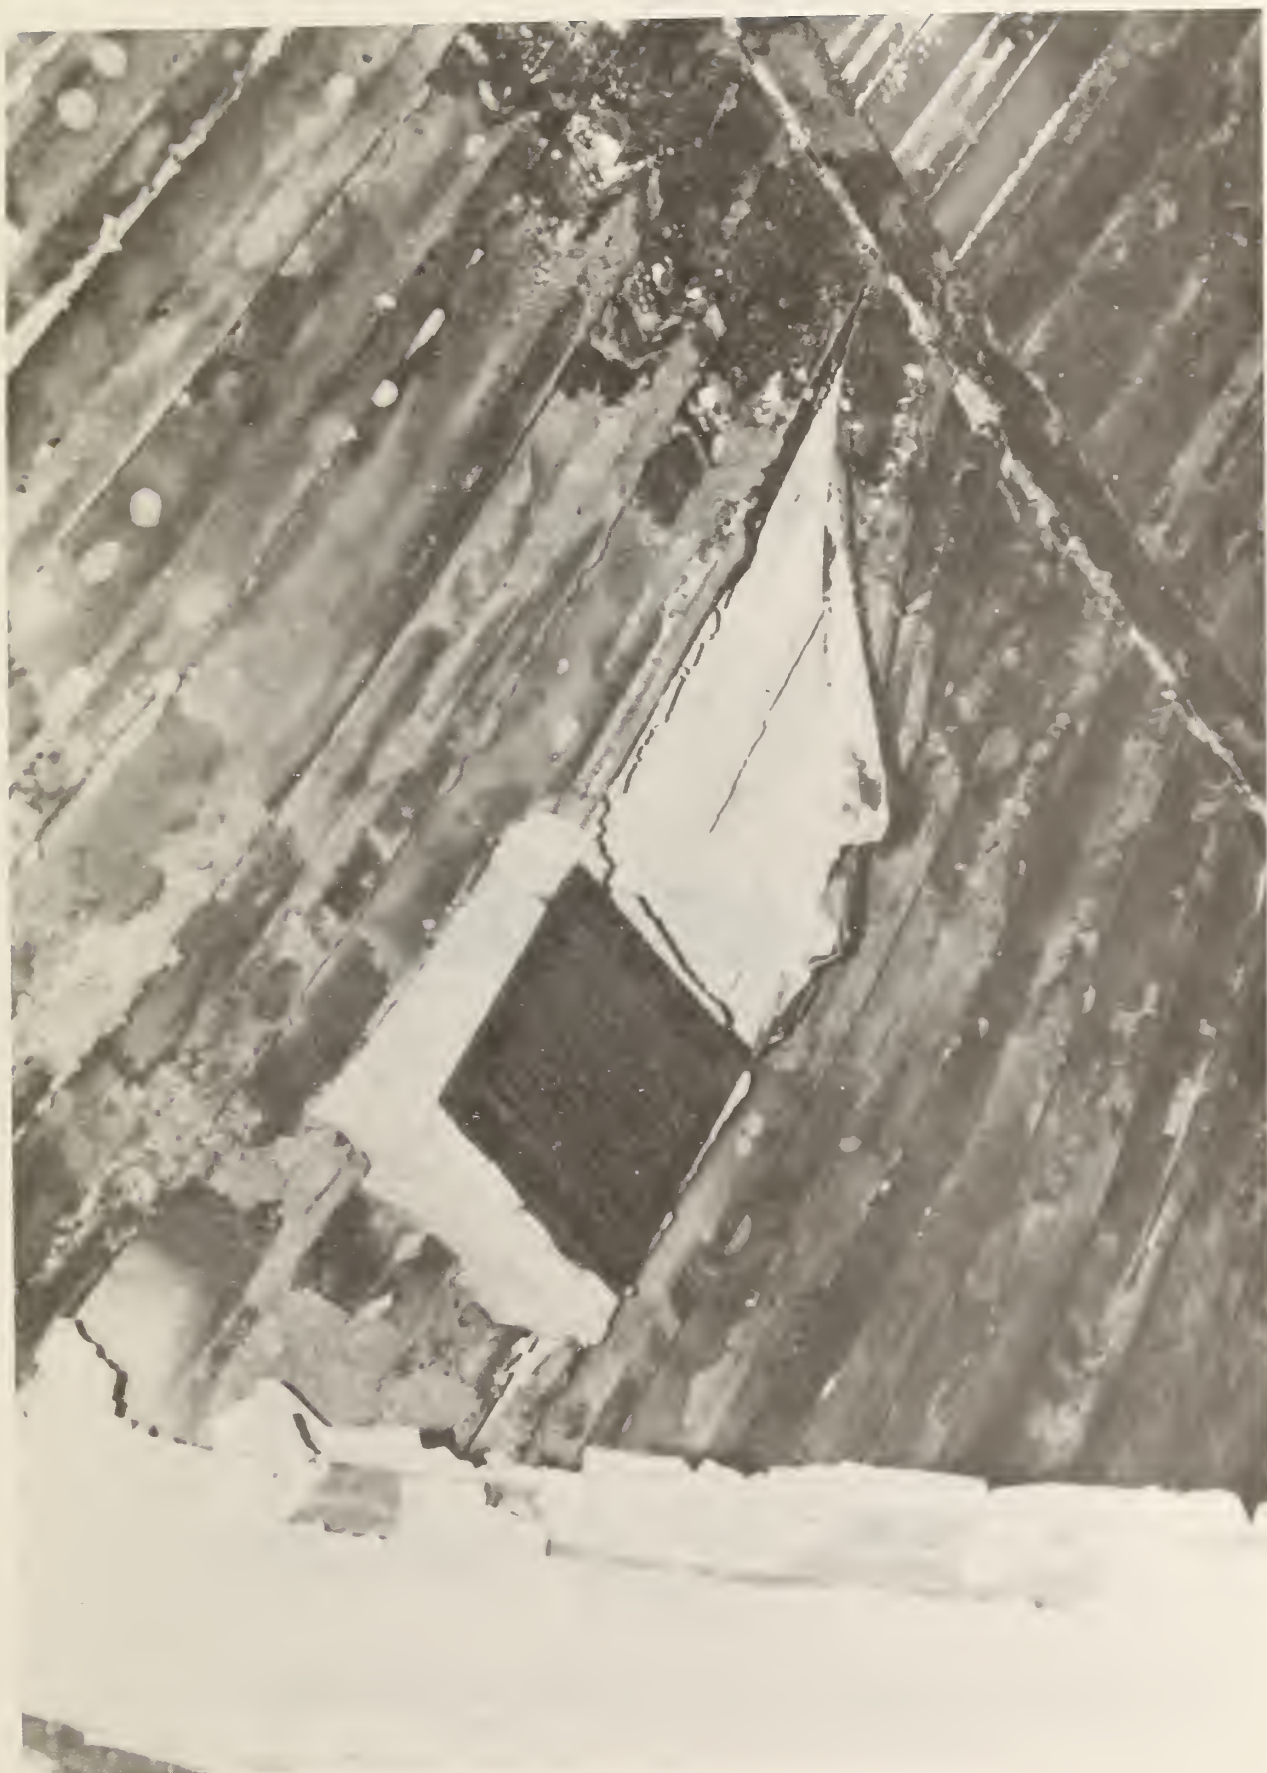
Figure 24. Photograph showing bottom of walk-on deck after test 1

1. Most of the inside layer of gypsum board is still in place around the center column. The metal studs supporting the gypsum board on the column are still in place, figure 24.
2. The pier has spalled on the side exposed to the furnace burner. One piece of concrete approximately 2 inches deep and 6 to 8 inches in diameter has broken away from the pier.
3. The walk-on deck between the purlins has sagged. The metal flooring has dropped away from the concrete floor at one place near the return duct and is sagging approximately one foot below the bottom of the current floor level, figure 24.
4. About 75 to 85 percent of the fireproofing on all of the purlins has dropped off. Only three spots are left where fireproofing remains.
5. All of the firestop material is still in place at the duct penetrations.
6. No signs of burning were noted in the interstitial space.

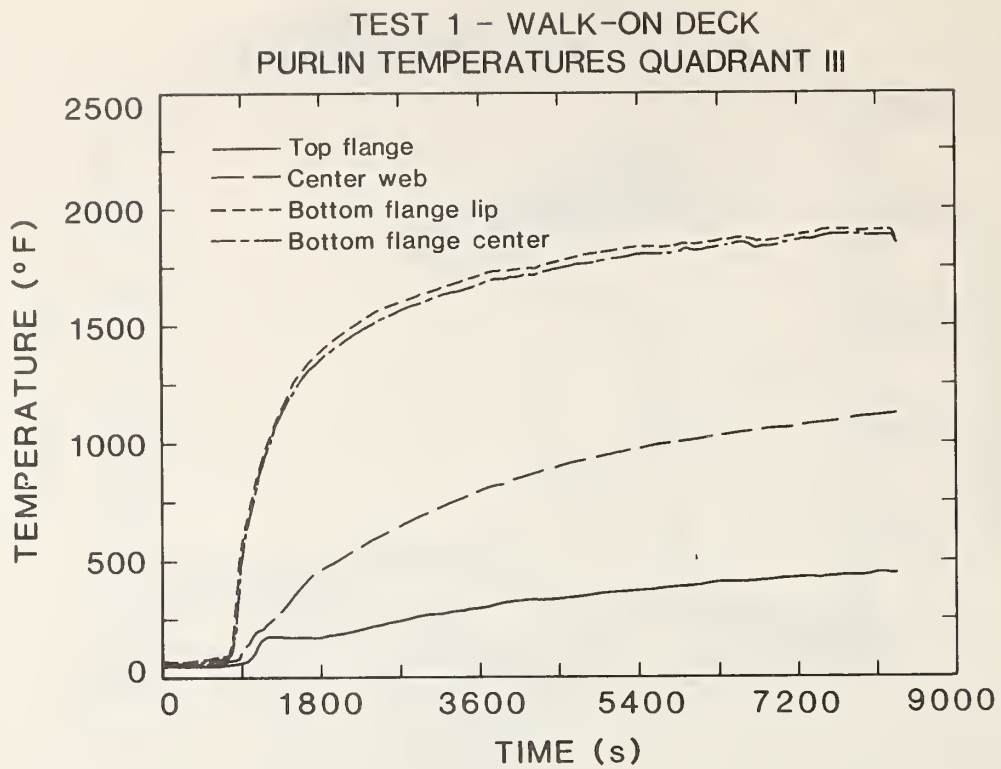
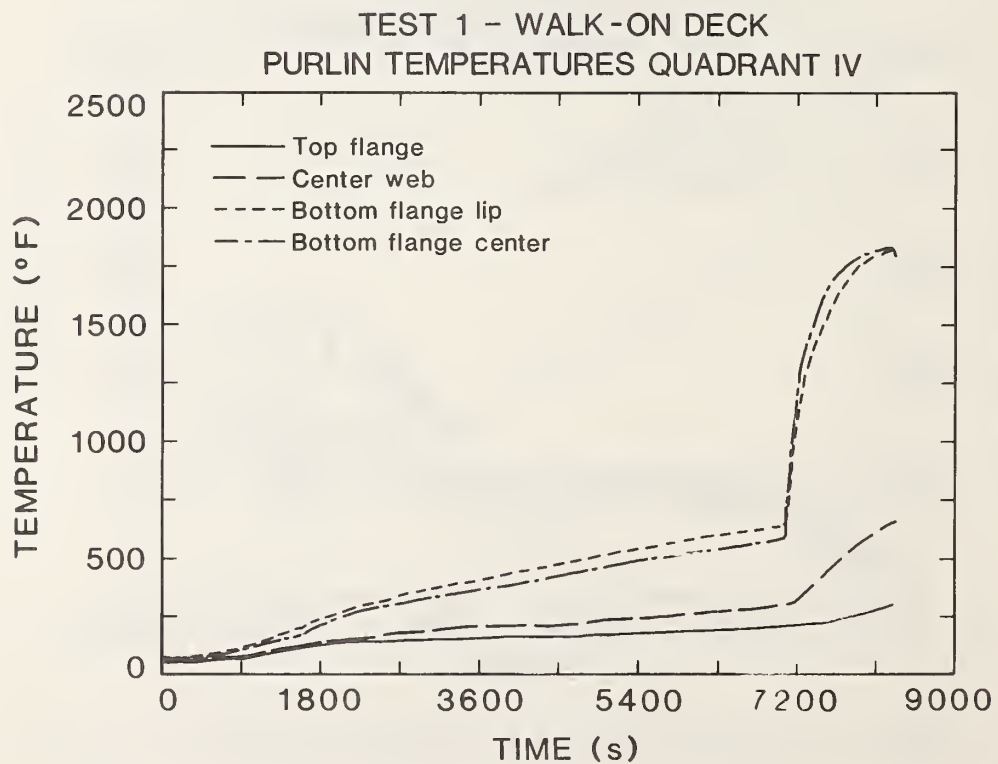
Other test data demonstrated the significant effect associated with the loss of fireproofing protecting the walk-on deck purlins. Figures 39 to 42 show the temperature history for these purlins. The purlin sections in quadrants I and III showed early temperature failures. These failures occurred at 40 and 26 minutes, respectively, resulting from fireproofing
